| 2700-FM-BAQ0023 2/2015 pennsylvania DEPARTMENT OF ENVIRONMENTAL PROTECTION | | | <h2 style="margin: 0;">INSPECTION REPORT</h2> | | Commonwealth of Pennsylvania Department of Environmental Protection Air Quality Program | | |
| Company Name: Kingdom Provisions | | | Municipality: Plumstead Twp | | County: Backs | | |

| <input type="checkbox"/> Operating Permit Inspection (PI) | <input type="checkbox"/> Initial Permit Inspection (IPI) | <input checked="" type="checkbox"/> Complaint Inspection (CI) |

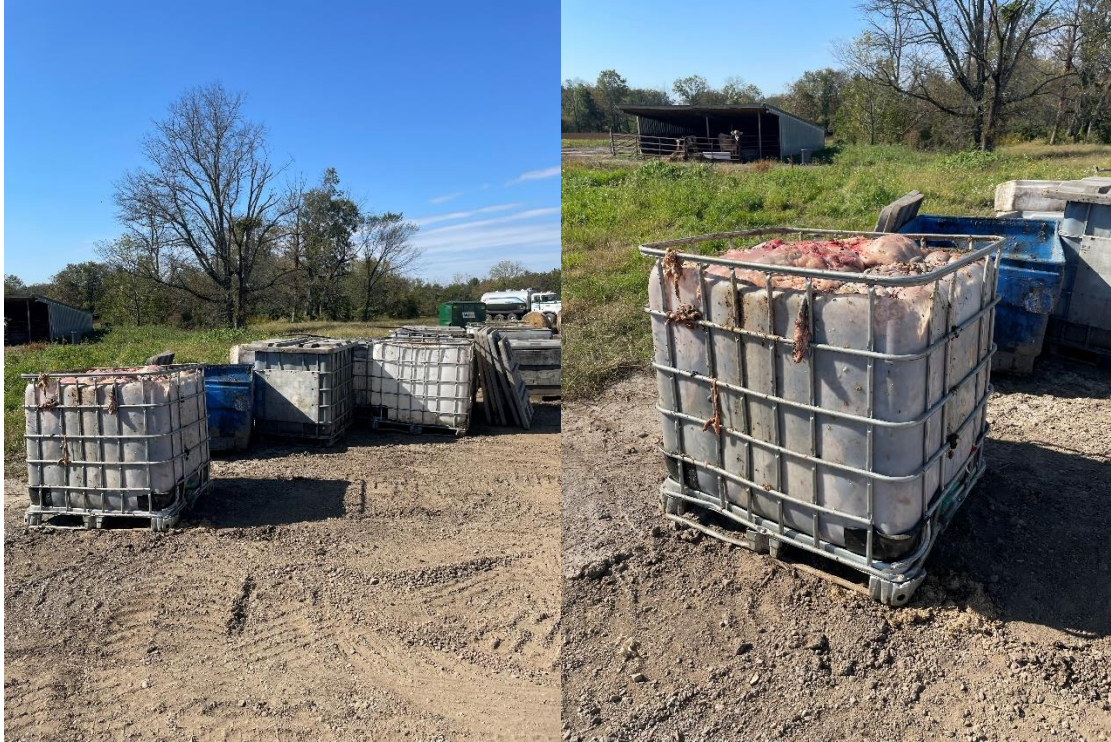
Photos 1 and 2 – Rendering bin storage area with a couple rendering bins that were uncovered and full and/or had not been rinsed out

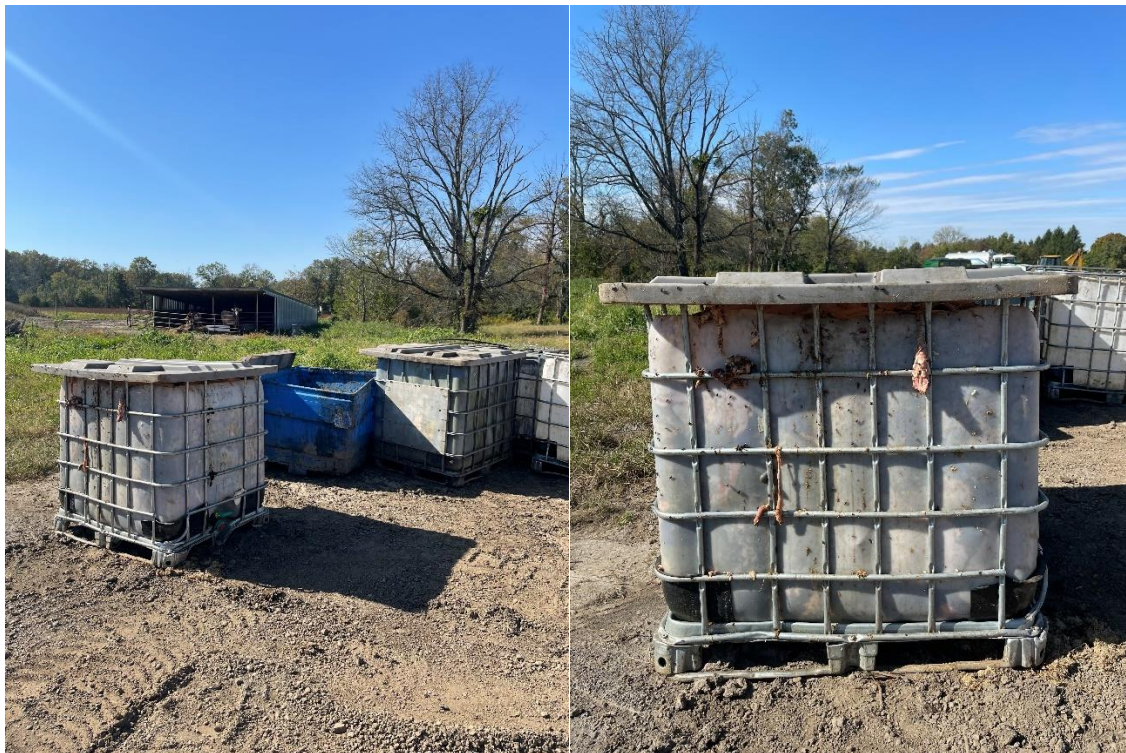
Photos 3 and 4 – Rendering bin with lid placed on it which did not make a tight seal

Comments/Recommendations: Enforcement since last FCE ☐ Yes ☐ No (If yes, attach summary)
Molly Goodman (DEP waste) and I arrived on site at 2:00 PM to conduct a Complaint Inspection. We met with Kerry Rush who showed us to the rendering bin storage area and the dumpster area. I noted a strong rendering/decomposing type odor in those areas that appeared to be present only within those areas. Winds were W at 3mph at the time of inspection, and it was sunny and 70°F. A couple rendering bins were uncovered and the full and/or had not been rinsed out. Mr. Rush instructed workers to cover the bins with plastic and lids, which they did. Mr. Rush stated that they are waiting to get new bins which have a tighter seal to better

Control odors, however the bins are on back order. Ms. Goodman and I also recommended covering the top of the dumpster with plastic since it doesn't have a tight seal either. The dumpster lid and side door were closed. I noted a few animal remains / fat on the ground near the bins and dumpster, and Mr. Rush said they would be immediately cleaned up going forward. I noted that the salted hide trailer was moved closer to the building and the remains that were near the previous location had been removed. The former compost area appeared more level and I noted very little standing water. Mr. Rush stated that MORAL still comes to pick up renderings on Mondays, Wednesdays, and Fridays, and waste management comes to empty the dumpster on Tuesdays and Thursdays. I observed waste management empty the dumpster at 3:08 PM, and I noted rendering / decomposing odors in the facility's driveway at that time. Mr. Rush stated that they are still not burning / smelting animal carcasses / hair and they are still planning to purchase a refrigerated trailer. I observed a truck come to empty an underground tank that stores wastewater and blood from the facility, which did not appear to cause odors.

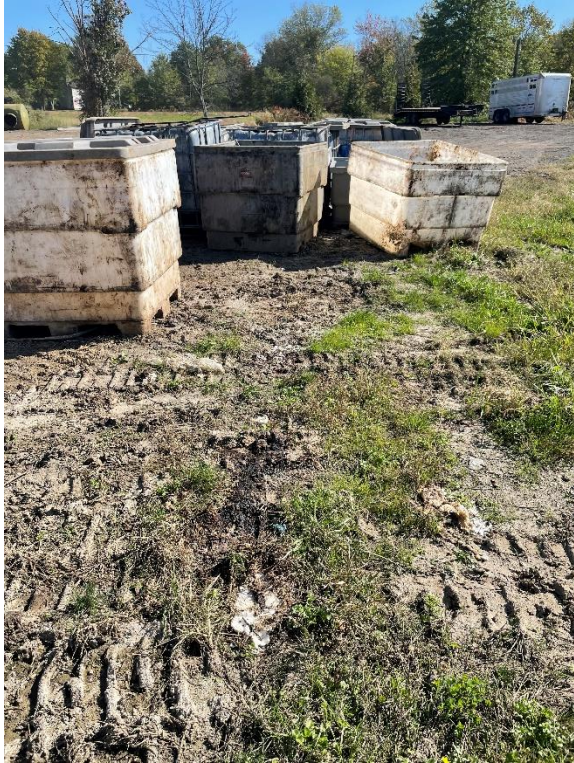
Photo 5 – A few animal remains/fat on the ground near the rendering bins
Taken by Jennifer Ramos-Buschmann on 10/12/23, 2:15 PM

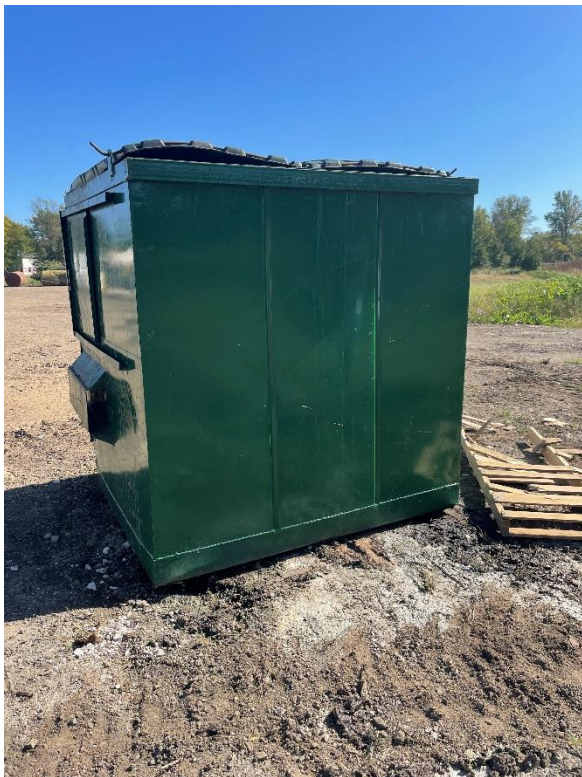
Photo 6 – Dumpster with side door and lid closed which did not make a tight seal
Taken by Jennifer Ramos-Buschmann on 10/12/23, 2:18 PM

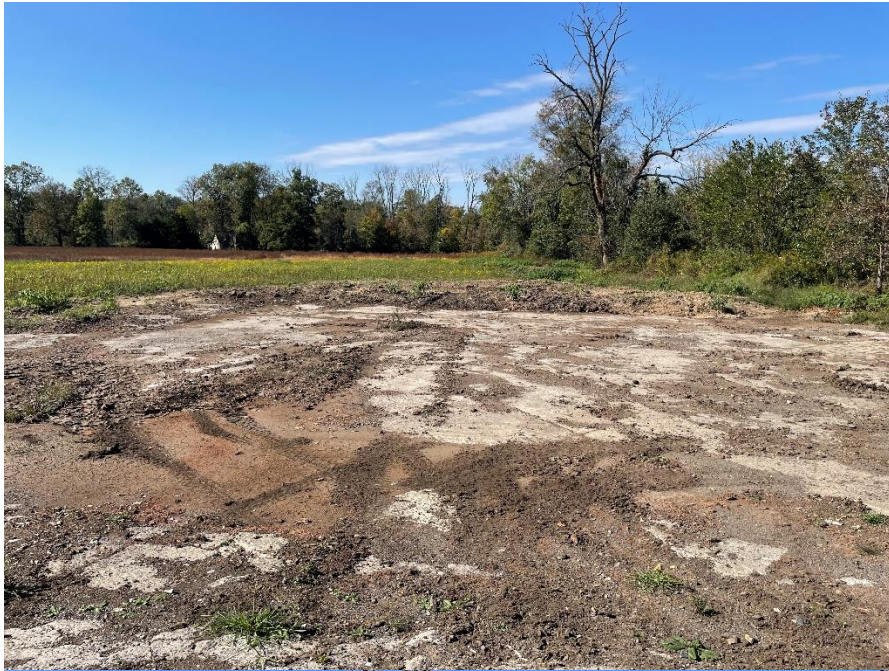
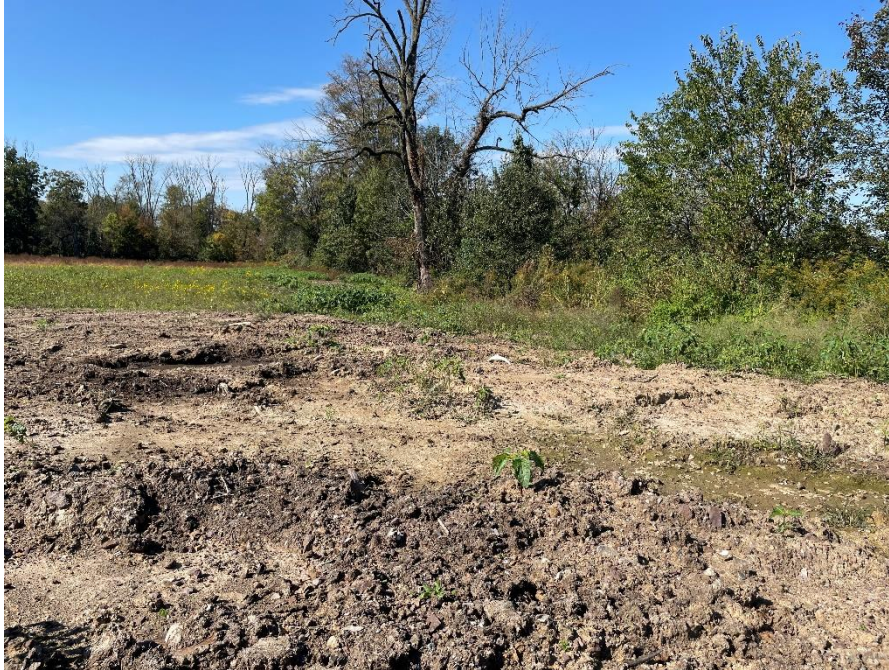
Photos 7 and 8 – Former composting area which appeared more level with very little standing water
Taken by Jennifer Ramos-Buschmann on 10/12/23, 2:20 PM and 2:21 PM

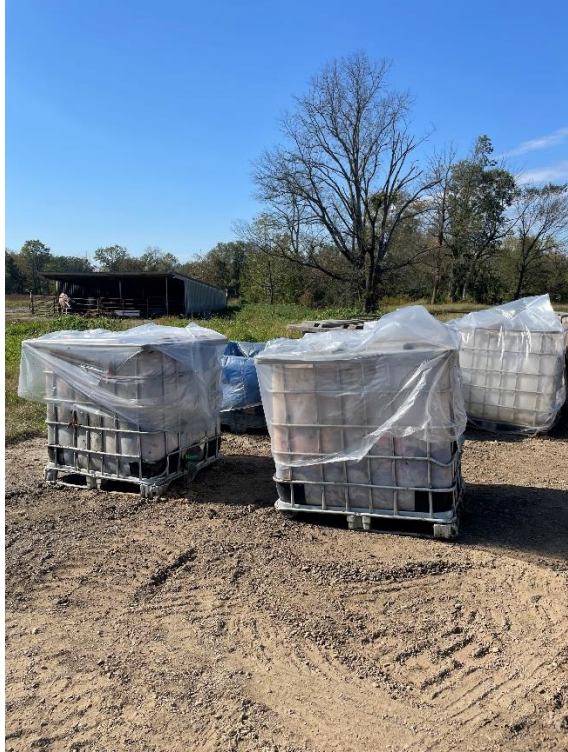
Photo 9 – Rendering bins which were covered in plastic
Taken by Jennifer Ramos-Buschmann on 10/12/23, 2:23 PM

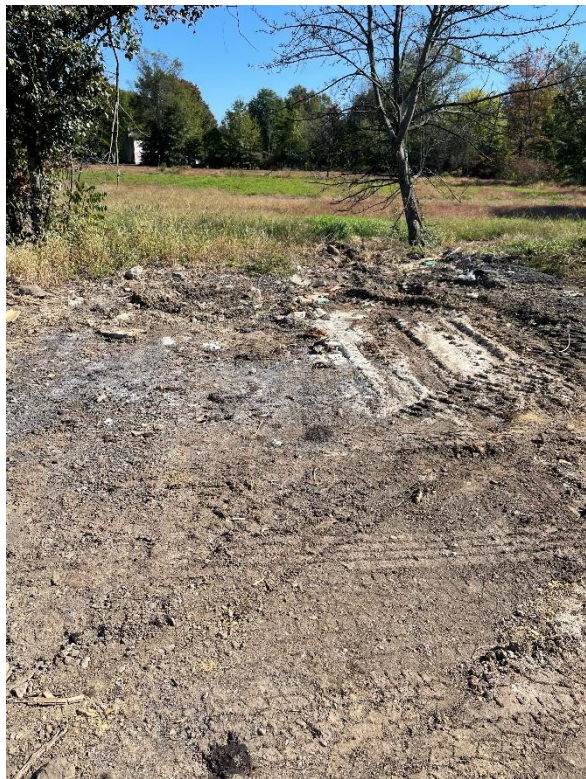
Photo 10 – Previous location of salted cow hides trailer with remains on ground removed
Taken by Jennifer Ramos-Buschmann on 10/12/23, 2:24 PM
