Department of Environmental Protection		GENERAL INSPECTION REPORT		Bureau of Land Recycling and Waste Management	
Type of Inspection	WM Identification Number	Entry Time/Date		Inspection ID	
Complaint Investigation	Site ID: 865337	6/6/2023		3569822	
Facility/Incident Name and Location				Municipality	
Kingdom Provisions 5960 Durham Road Pipersville, PA 18947				Plumstead	
Name, Address of Responsible Official				County	
Kerry Rush				Bucks	
Title				Interviewed	
Ephriam Stoltzfus Brent Pressley				Yes x <input checked="" type="checkbox"/> No <input type="checkbox"/>	
Telephone					
215-767-8943

On June 6, 2023, I, Molly Goodman – Solid Waste Specialist, conducted a complaint investigation regarding odors alleged to be coming from Kingdom Provisions, located at 5960 Durham Road Pipersville PA 18947. Paul Jardel, Water Quality Specialist, was additionally in attendance. Complaints received by the Department allege that odors smelling like sewage and rotting flesh have been affecting the nearby neighborhood and expressed concerns that run off from the site could be entering a nearby stream or potentially contaminating well water.

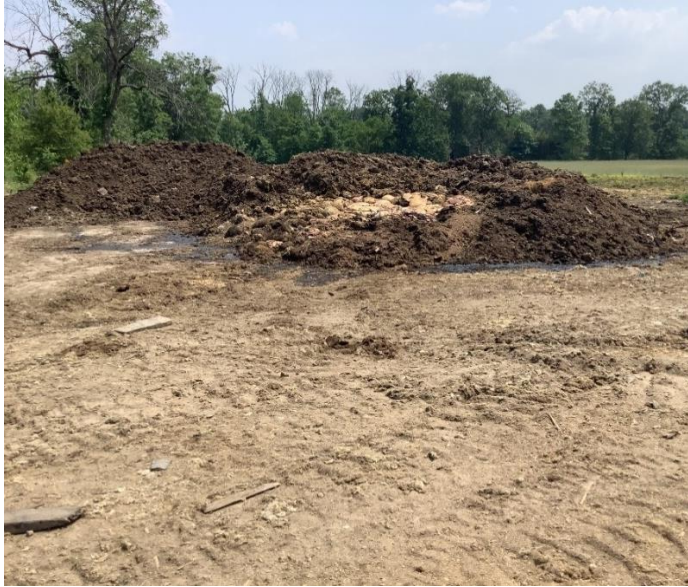
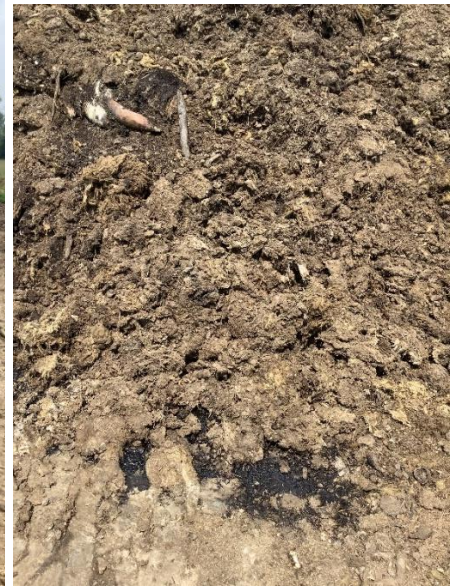
The compost pile (Image 1) was observed to be completely confined to the concrete pad. Mr. Rush stated that animal remains are layered with a mixture of animal waste and saw dust/wood that is received from Heacock Lumber. The majority of the pile was covered except for some exposed material recently placed onto the pile. Kingdom Provisions should provide cover upon the placement of any material. Based on a visual inspection, it appeared that no other materials have been mixed in or added to the compost.

Image 1: Compost Pile (left), Compost (right)
Taken by Molly Goodman on 6/6/2023

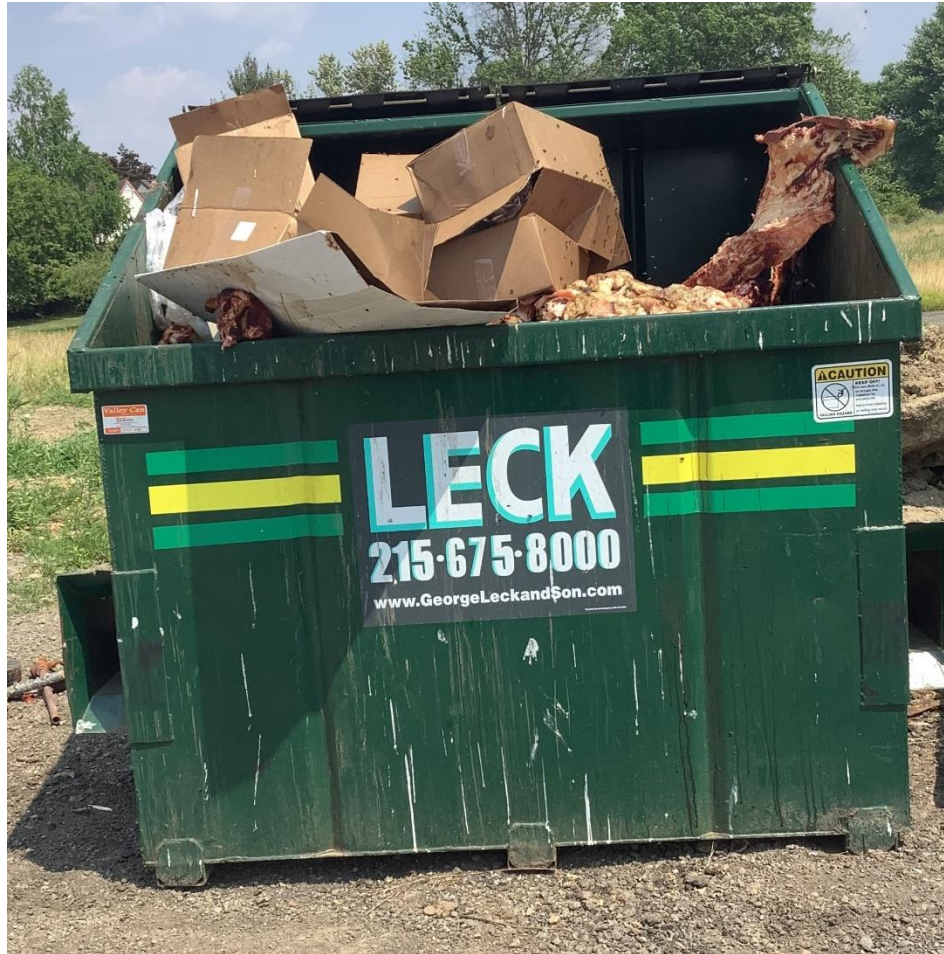
Mr. Rush additionally suggested the odor is coming from a container located behind the slaughterhouse. Noticeably strong odors of decaying animal remains were detected within approximately 20' of the container. Mr. Rush stated that the container was used for waste bones and fat. Primarily cardboard and remains of slaughtered animals were observed in the container (Image 2) and debris, including parts of an animal carcass, was observed outside the container (Image 3). Upon closer inspection, the container was observed to harbor a large number of vectors (Image 4). **Kingdom Provisions failed to store putrescible waste in a container that is sealed, watertight, leak proof, insect-proof and rodent-proof contrary to 25 PA Code 299.121(c) and did not minimize and control conditions that create a public nuisance, contrary to 25 PA Code 299.115(a) and (b).** Mr. Rush stated that the waste will be removed from the site in a timely manner and documentation will be provided that will demonstrate the waste has been disposed of properly.

Image 2: Container at Kingdom Provisions
Taken by Molly Goodman on 6/6/2023

Kingdom Provisions should respond within 10 days of receipt of this inspection report with documentation in the form of a disposal receipt demonstrating the proper disposal of the putrescible waste in the dumpster. Furthermore, Kingdom Provisions should provide a plan describing future waste handling from the slaughtering operation.

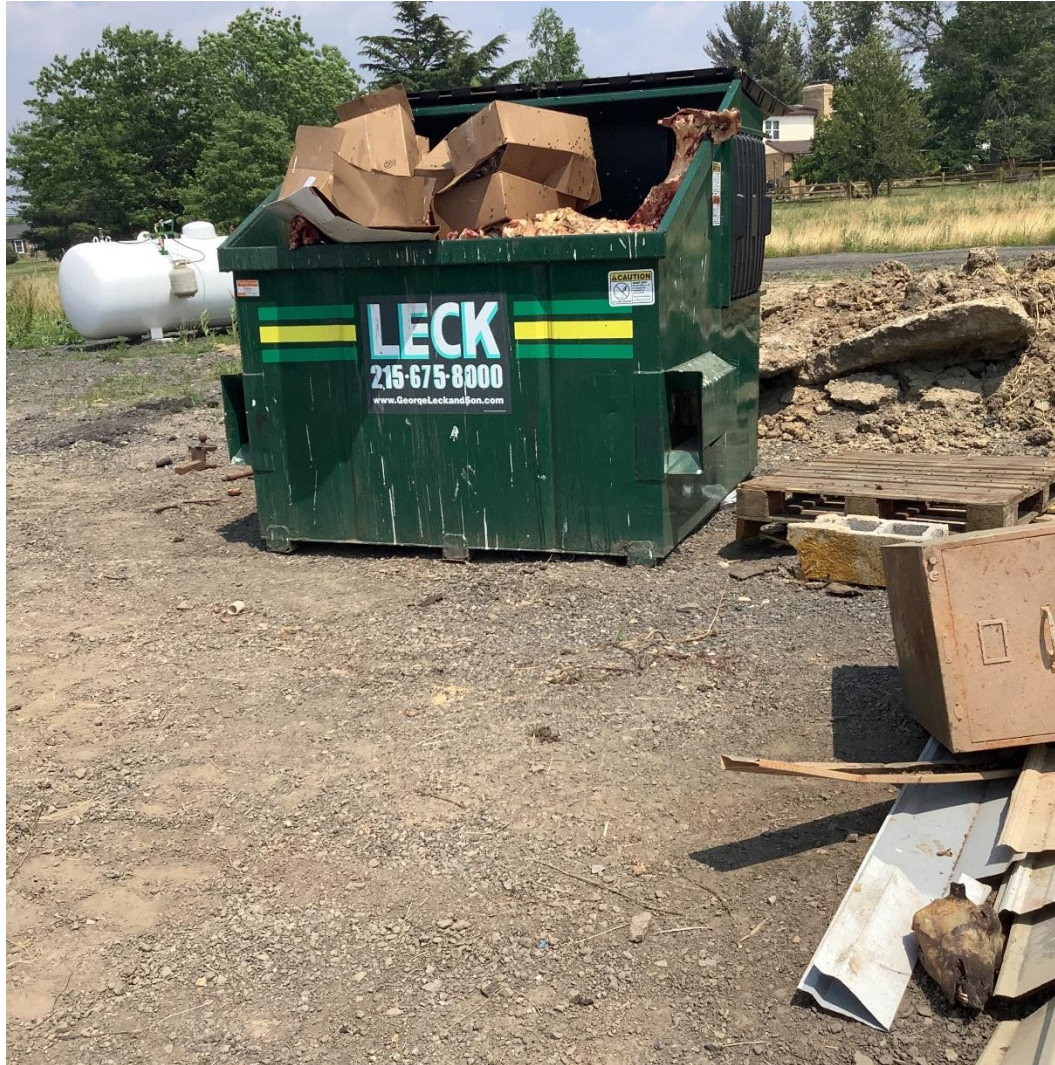
Image 3: Dumpster containing cardboard, animal remains, and surrounding debris
Taken by Molly Goodman on 6/6/2023

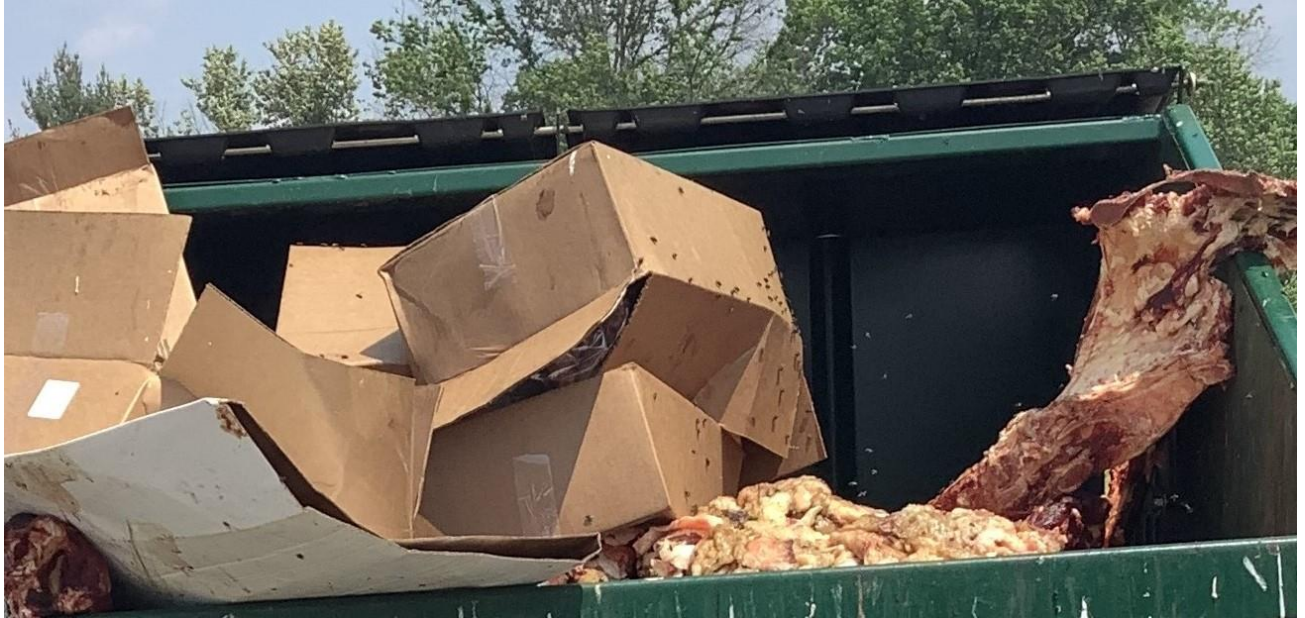
Image 4: Vectors observed in the container
Taken by Molly Goodman on 6/6/2023

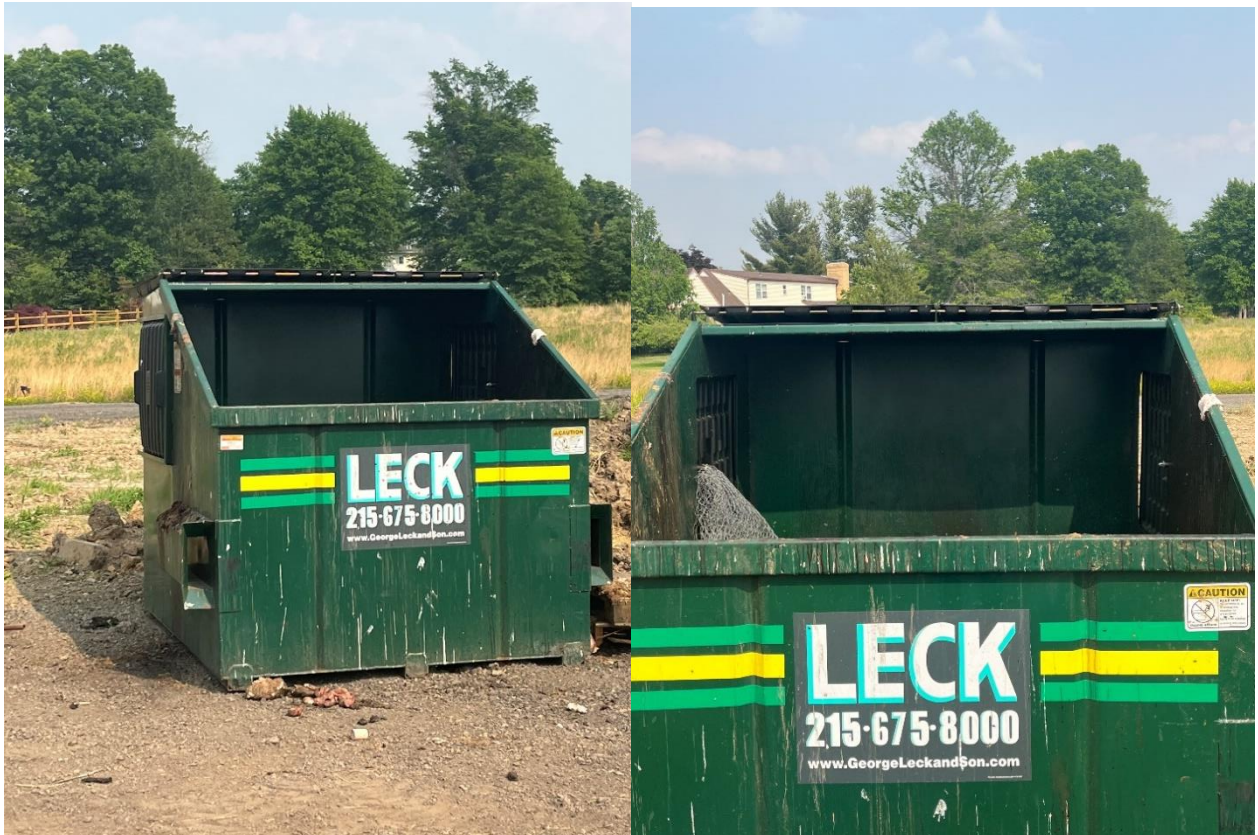
Mr. Pressley stated that the container is regularly picked up on a weekly basis and was able to provide photographs (Image 5) of the empty container. The Department has not yet received waste receipts or other documentation to indicate the waste was received by a disposal facility. Mr. Pressley was reminded that the container must be maintained (by cleaning, covering, and emptying) on a regular basis to prevent any odor problems and no waste should be stored on the ground surrounding the container.

Image 5: Photographs of container that appears emptied
Provided by Brent Pressley on 6/8/2023
