2700-FM-BAQ0023 2/2015 pennsylvania pepartment of environmental protection		INSPECTION	N REPORT		Commonwealth of Pennsylvania Department of Environmental Protection Air Quality Program			
Date(s) of Inspection: TV PA	ŧ	Permit #(s):	Expiration	n Date:	Case	#:	PF ID #:	
			·		***		868000	
Company Name: Kngdom Provisions Plant Name: Municipality: Plant Stead Physical Location:		Plumstead	tup		County: Bucks			
		ž.	Federal ID — Plant Code #:		: 			
Responsible Official:				Mailing Address:				
Brent Pressley			5160 Ourham Rd.					
Brent Pressley Title: Plant Manager Phone #(s):			5960 Ourham Rd. Pipersville, PA 18947					
Phone #(s): 215 - 767 - 8943								
Mark (X) All Inspection Types That Apply To This Inspection:								
Full Compliance Evaluation (FCE)		Plan Approval Inspection	n		File Review (FR)			
Operating Permit Inspection (PI)		Initial Permit Inspection (IPI)			X	Complaint Inspection (CI)		
Routine/Partial (RTPT)		Follow-Up Inspection (Ref. Date:)				Sample Collection (SC)

Page 1 of 2 eFacts Inspection ID#: 3593792 Date: 8/1/23 Reviewed By								
☐ White – Regional Office			ellow –		·		ink – District Office

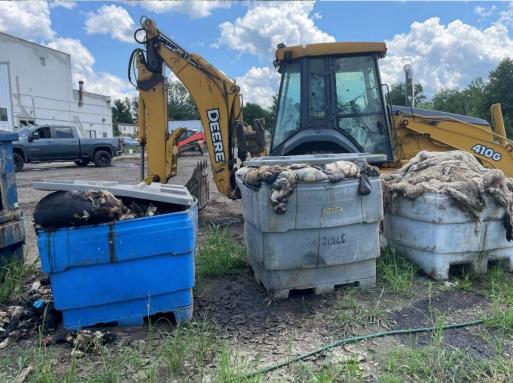
and partially closed rendered bing filled with animal remains 1 skins								
			<u>M1</u>	14 11	<u>u</u>	animal	remains sking	
bones in the bin of a front end loader. Ms. Prissley Stated that								
the His were previously chised, but the inner organs expand in the								
heat and caused the lies to open. Ms. Pressley also stated that								
Compliance Status: ☐ In ☐ Out ☒️ Pending ☐ Awaiting Co. R			teport Needs a Follow-Up Inspection? Yes No					
Company Representative:	Title	Office		Signature:			Date:	
Amber Pressley	7	nanager		morress 73			73123	
DEP Representative: Signature: Date/Time:					Date/Time: 7/31/23			
JUNIO TEAMOS-BUSCHMann MG SPECIALIST JUNIO 14MB-BUSUMAN 3125 pm								
This document is official notification that a representative of the Department of Environmental Protection, Air Quality Program, inspected the identified site. The findings of this inspection are shown above and on any attached pages, and may include violations uncovered during the inspection. Violations may also be discovered upon review of sample results or from any additional review of Department records. Notification will be forthcoming, if such violations are noted.

Photos 3 and 4 - Containers of entrails, heads, and skins of slaughtered animals Taken by Jennifer Ramos-Buschmann on 7/31/23, 12:51 PM and 12:58 PM

2700-FM-AQ0024 Rev. 2/99 pennsylvania	INSPECTION REPORT	Commonwealth of Pennsylvania Department of Environmental Protection					
DEPARTMENT OF ENVIRONMENTAL PROTECTION	Continued	Air Quality Program					
à newer employée ha		too high on that they					
MC 4000 441 0 100 100 100 100 100							
can be properly closed. Ms. Pressley Student that Mapac now							
Comes on Mondays, Wednesdays, and Fridays to pick up the							
remains, lobserved a Mojac track pickup the remains in							
the bins around 2:00-2:7M. Ms. Pressley stated that only the							
animal hides are currently being added to the compost pile.							
I recommended they try to find another way to dispose of the							
hides, because they may be contributing to odors. I noted the							
rendering type sours near the compost pile and the							
rendering bith area. I noted a burn bowiel and cardbourd							
boxes near the rendering bin area. Ms, pressley stated that

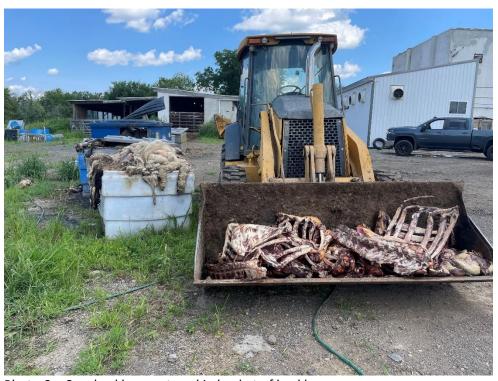
Photo 6 – Cow backbones stored in bucket of backhoe Taken by Jennifer Ramos-Buschmann on 7/31/23, 12:59 PM

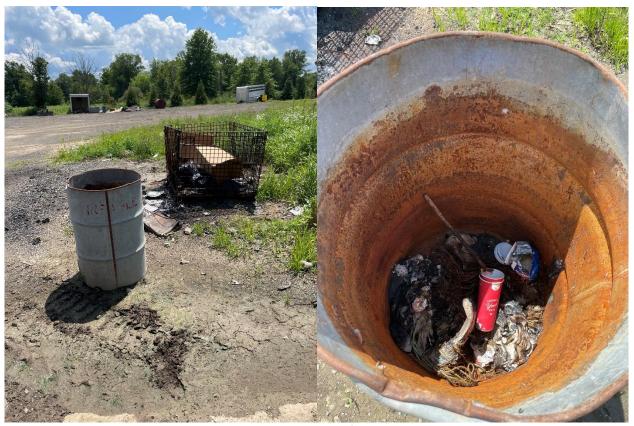
they burn cardboard boxes that conit be used for Packaging							
meat. I informed her of the open burning regulation and							
requested that they case open burning going forward. During							
in 7/12/23 Mspection, I noted smoke country from the facility's							
vents and something		ground. Ms, Pressley					
Stated that they sometimes burn the har off an mal carcasses							
and before selling them, which is what causes the smoke, and							
the smoldering would have been from burning cardboard boxes, MS.							
Pressley Stated that they may be considering purchasing an minerator							
to dispose of unuanted animal remains. I explained that they would							
likely need an air quality permit to operate an momerator							
and I would email her more information on how to obtain a							
permit should they choose to do so. The compost pile was covered							
at the time of inspection except for a whole con curcuss

Photos 7 and 8 – Burn barrel containing a conglomerate of solid waste and animal remains Taken by Jennifer Ramos-Buschmann on 7/31/23, 1:02 PM
