2700-FM-BAQ0023 2/2015 pennsylvania DEPARTMENT OF ENVIRONMENTAL PROTECTION			<h2 style="margin: 0;">INSPECTION REPORT</h2>		Commonwealth of Pennsylvania Department of Environmental Protection Air Quality Program	
Date(s) of Inspection: 4/16/24	TV <input type="checkbox"/> SM <input type="checkbox"/> NM <input type="checkbox"/>	PA <input type="checkbox"/> GP <input type="checkbox"/> MEGA <input type="checkbox"/>	Permit #(s): _____	Expiration Date: _____	Case #: _____	PF ID #: 868000
Company Name: Kingdom Provisions			Municipality: Plumstead Twp		County: Bucks	
Plant Name: Same as above			Physical Location: Same as below		Federal ID — Plant Code #:	
Responsible Official: Ephraim Stoltzfus				Mailing Address: 5960 Durham Rd.		
Title: Owner				Pipersville, PA 18947		
Phone #(s): 267-914-7430

Kingdom Provisions

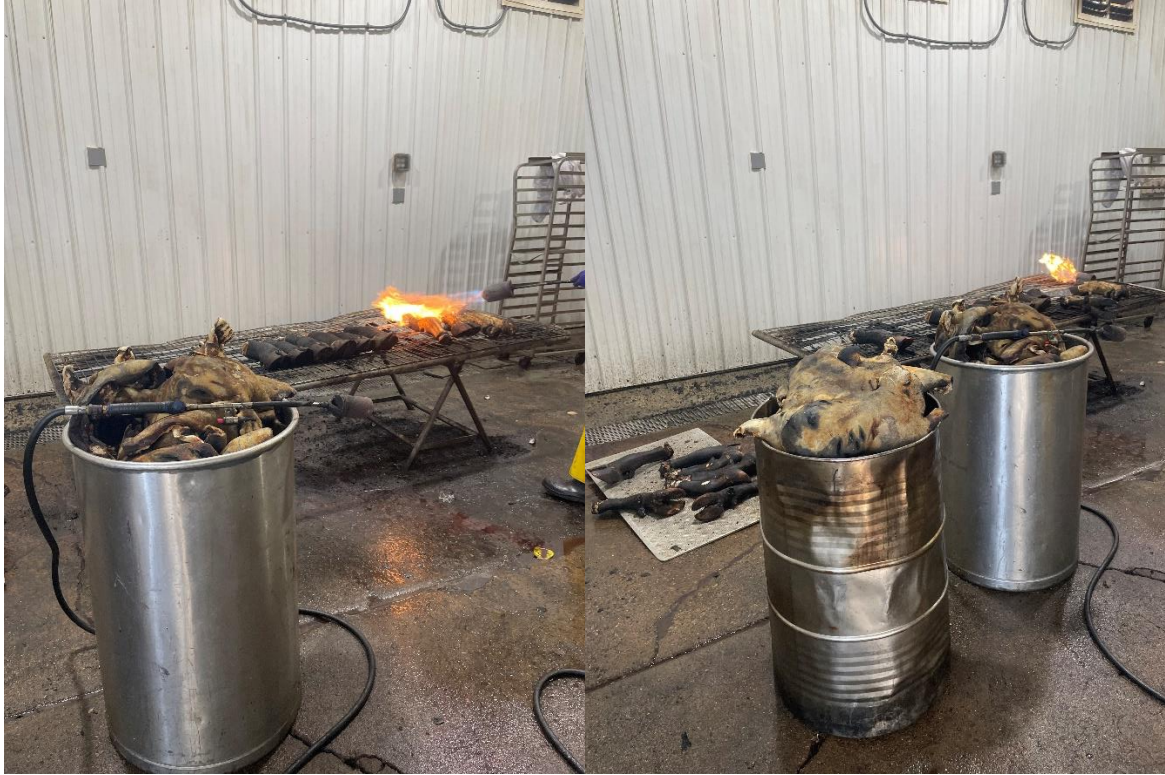
I arrived on site at 2:40 PM to conduct an odor complaint inspection. It was 69°F and sunny, and winds were NW at 5 mph. I met with Ephraim Stoltzfus who showed me to the singeing area as I told him I noted burning hair odors upon entering the facility driveway. I observed that singeing was actively taking place. I noted no smoke and I noted burning hair odors. The singeing room has large vents that vent outside. We then went to the back of the facility and I noted three trash bins and the bucket of a small backhoe filled with animal body parts and skins. Mr. Stoltzfus stated that all rendering is placed in a truck throughout the day and taken for offsite.

Photos 1 and 2 – Singeing room with singeing actively taking place in Photo 1
Taken by Jennifer Ramos-Buschmann on 4/16/24, 3:52 PM and 3:50 PM

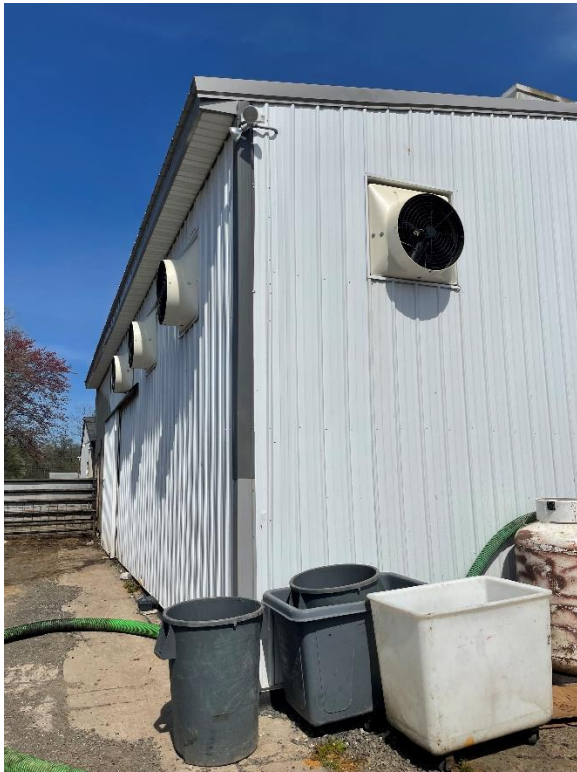
Photo 3 – Vents from singeing room
Taken by Jennifer Ramos-Buschmann on 4/16/24, 3:00 PM

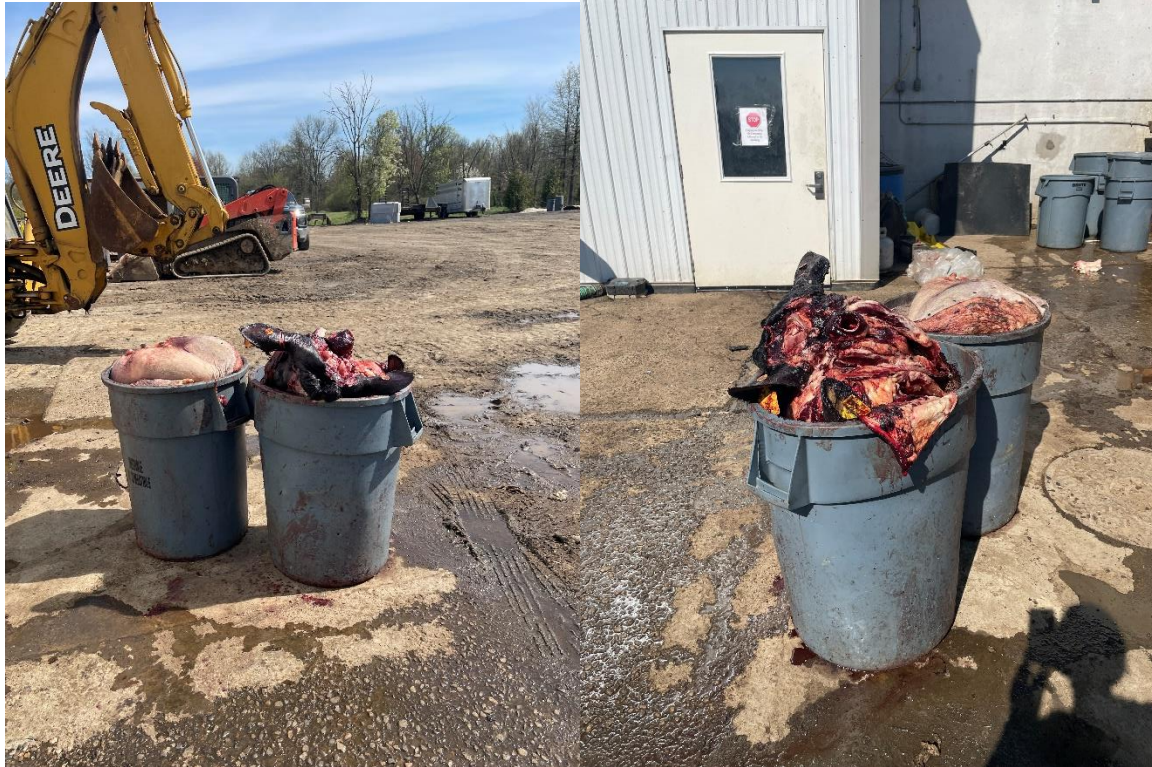
Photos 4 and 5 – Two of three trash bins filled with animal body parts
Taken by Jennifer Ramos-Buschmann on 4/16/24, 3:00 PM and 3:51 PM

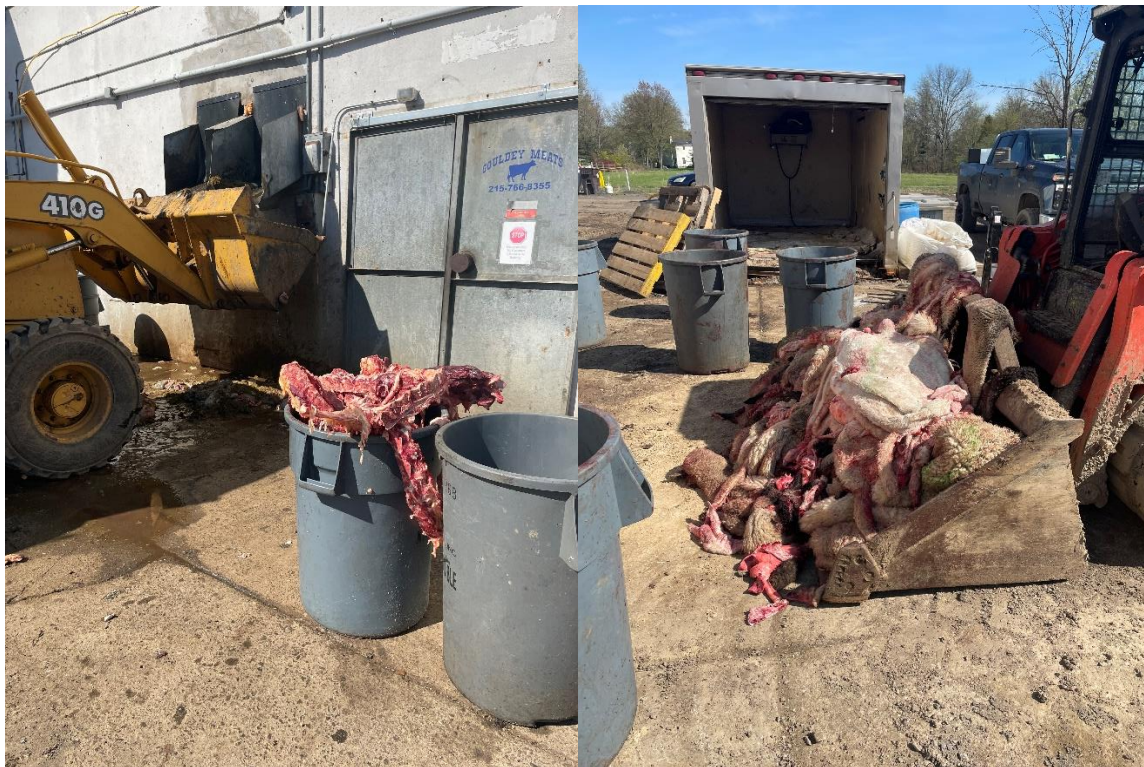
Photos 6 and 7 – Trash bin filled with animal body parts and bucket of backhoe filled with animal skins
Taken by Jennifer Ramos-Buschmann on 4/16/24, 3:51 PM

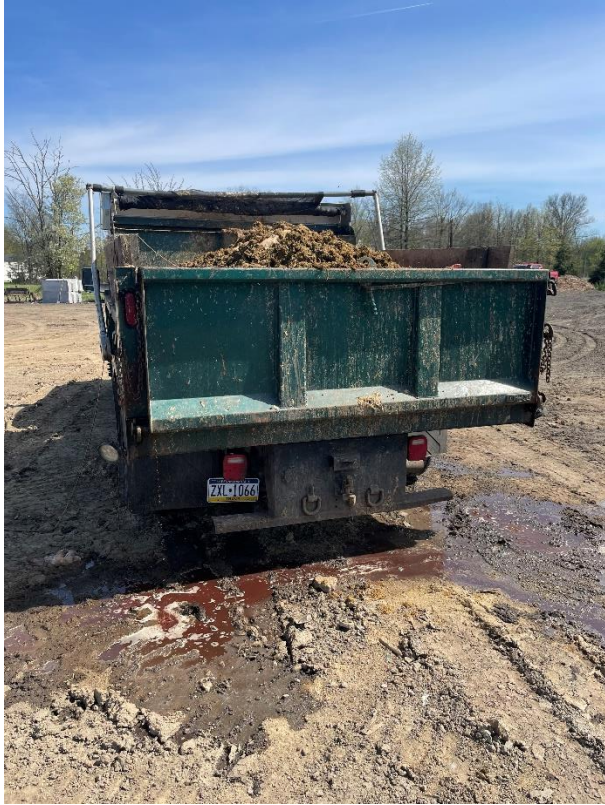
composting at the end of every day. I noted rendering odors near the truck. I also noted manure odors coming from two large piles of manure in the field to the right of the facility. Mr. Stoltzfus stated the barns were just cleaned and all the manure was removed and placed in the field. I observed salted and unsalted cow hides behind the facility; I did not note odors coming from them. Mr. Stoltzfus stated that they plan to begin composting the rendering animal remains again but in a field farther back on the property ~~and~~ within the next month. He stated it will be done properly this time and he is meeting with personnel from Plumstead Twp on 4/17/24 to discuss. I then walked along Durham Rd towards Stump Rd. and I noted burning hair and rendering odors at 3:25 PM and 3:41 PM. The odors appeared to linger for about 5-10 minutes. I spoke with a complainant who confirmed those were the odors they smelled throughout the day today and yesterday. Upon returning to the facility, I observed singeing was taking place again. Mr. Stoltzfus stated they singe animal body parts ~~about every day~~ throughout the day every day.

Photo 8 – Truck filled with rendering material which leaked blood and other bodily fluids
Taken by Jennifer Ramos-Buschmann on 4/16/24, 3:03 PM

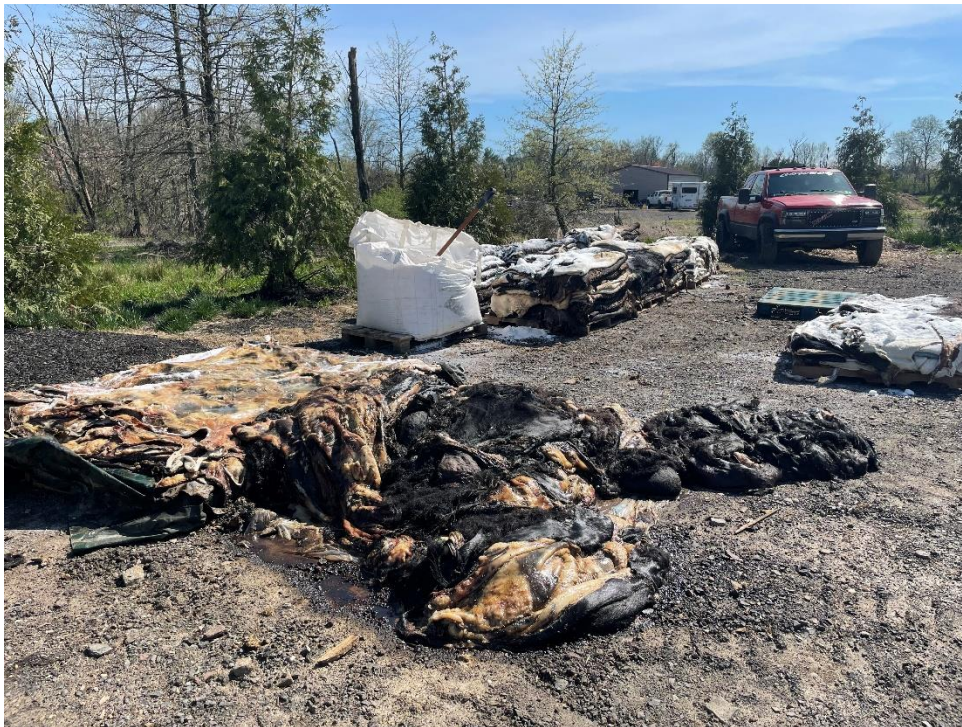
Photo 9 – Salted and unsalted cowhides drying in the sun
Taken by Jennifer Ramos-Buschmann on 4/16/24, 3:17 PM

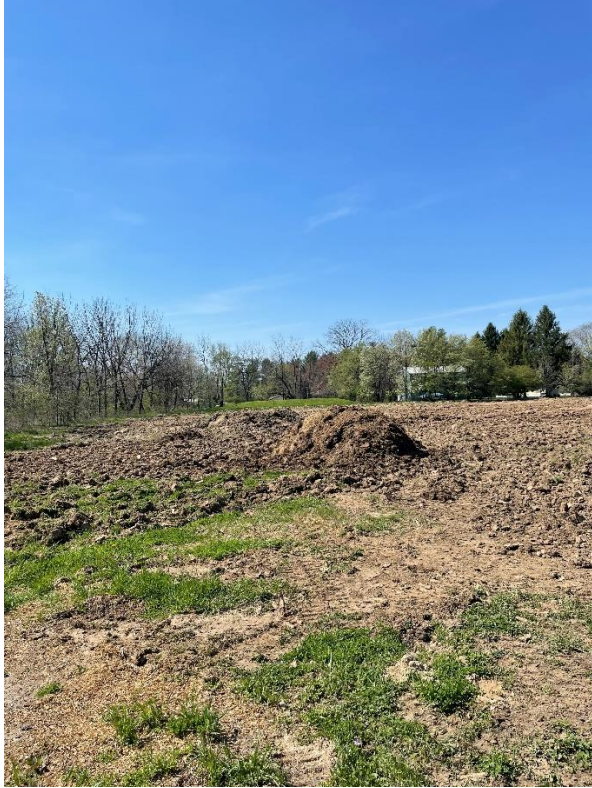
Photo 10 – Two piles of manure in the field to the right of the facility (when facing front of facility)
Taken by Jennifer Ramos-Buschmann on 4/16/24, 3:14 PM
