Department of Environmental Protection		GENERAL INSPECTION REPORT		Bureau of Land Recycling and Waste Management	
Type of Inspection Follow Up Inspection	WM Identification Number Site ID: 865337	Entry Time/Date 7/31/2023		Inspection ID 3593406	
Facility/Incident Name and Location Kingdom Provisions				Municipality Plumstead	
5960 Durham Road Pipersville PA 18947				County Bucks	
Name, Address of Responsible Official Amber Pressley			Title Manager		
Kerry Rush – Owner Ephriam Stoltzfus – Owner Brent Pressley - Manager			Telephone 215-767-8943		Interviewed Yes <input checked="" type="checkbox"/> No <input type="checkbox"/>

On July 31, 2023, I, Molly Goodman – Solid Waste Specialist, conducted an inspection of Kingdom Provisions at 5960 Durham Road Pipersville PA 18947. Jennifer Ramos-Buschmann, Air Quality Specialist, was additionally in attendance. The inspection was conducted as a follow up to prior inspections initiated in response to numerous complaints regarding strong odors emanating from the property. Previous inspections of the facility were conducted on April 12, 2023, June 6, 2023, and July 6, 2023. Due to site conditions observed during these inspections and today's inspe

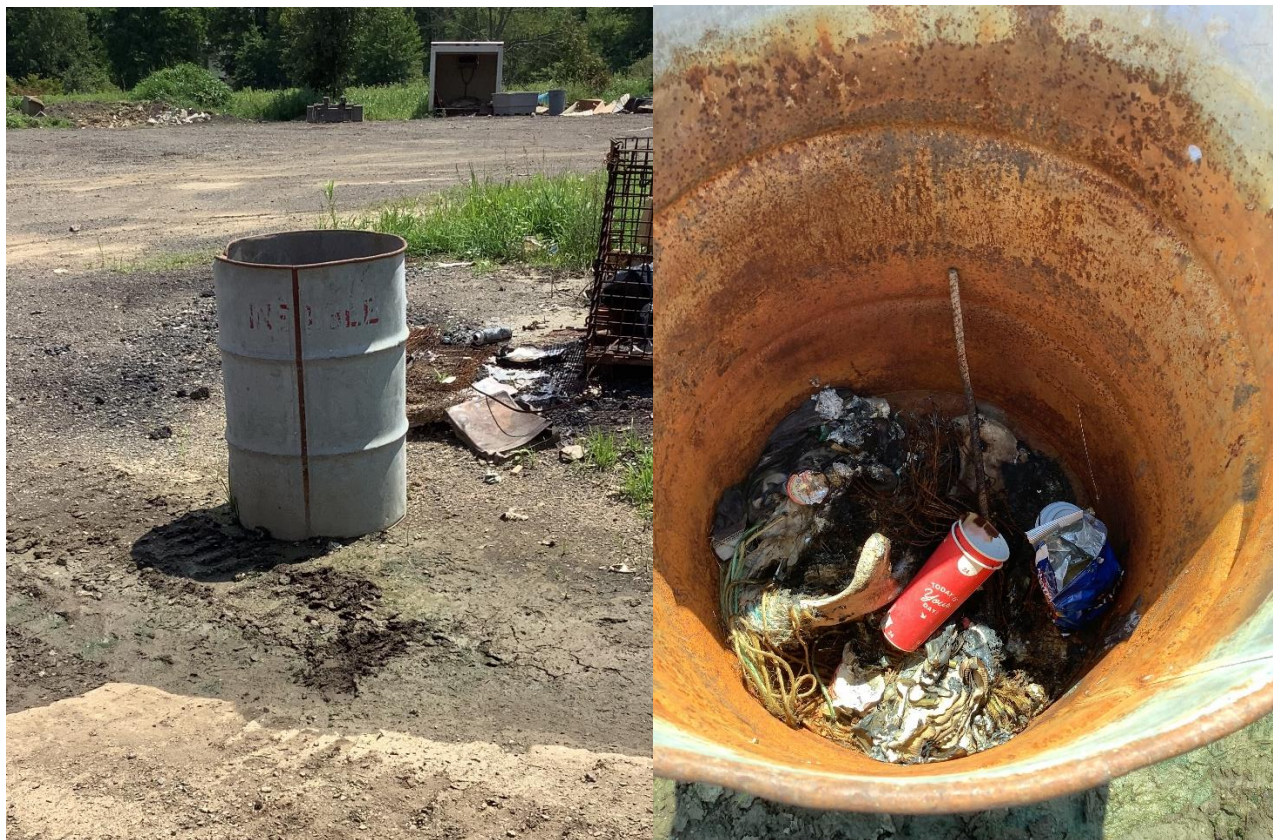
Ms. Pressley was at the site and available to discuss Kingdom Provisions' operations and provide a tour of the facility. A faint odor of decomposing flesh was detectable from the driveway of the Kingdom Provision's property. Ms. Pressley stated that animal remains are currently being added to the compost pile and the facility does not have plans to cease composting operations or remove the material. When questioned about the quantity of livestock being accepted at the facility, Ms. Pressley declined to provide an answer. The facility currently burns the hair off goats, sheep and cow carcasses in a building with exhaust fans. Ms. Pressley stated that Kingdom Provisions has been burning cardboard boxes for a long time and agreed to stop. A drum containing ash residue, solid waste, and part of the carcass of a deceased animal (Image 1) was observed behind the facility next to a cage containing cardboard boxes and other solid waste materials.

Image 1: Burn barrel containing a conglomerate of solid waste and animal remains
Taken by Molly Goodman on 7/31/2023 at 13:03

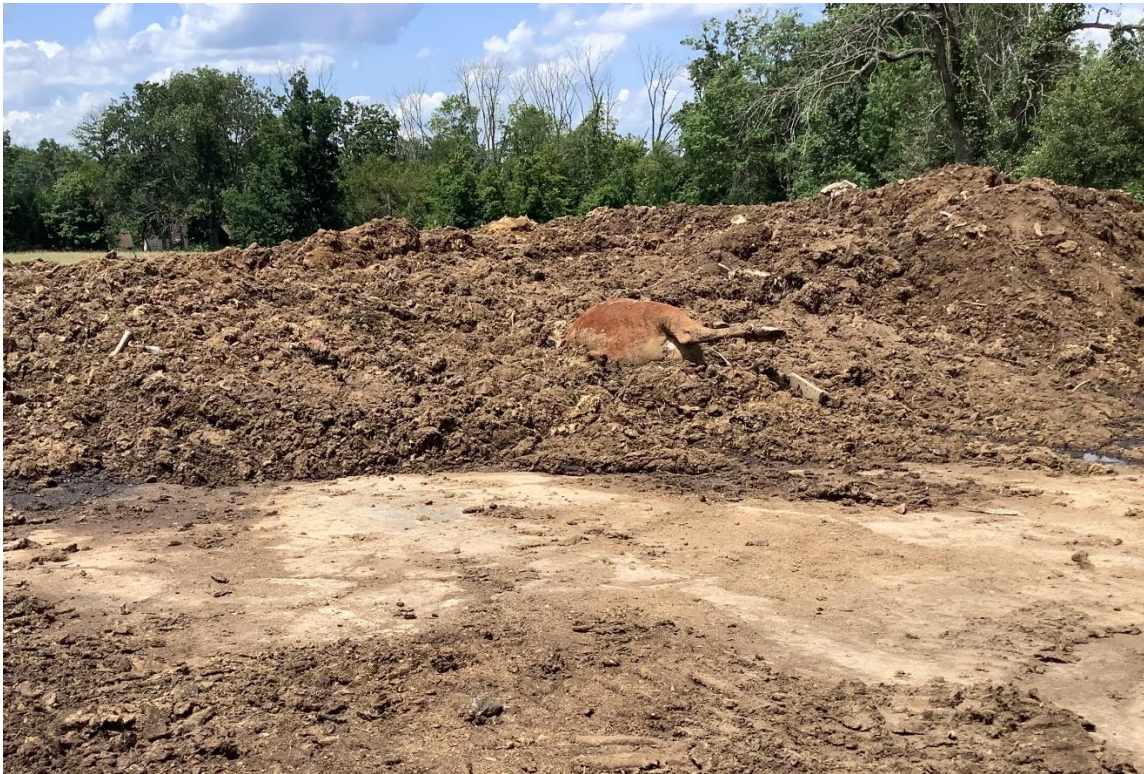
A complete cow carcass was observed on top of the pile of compost (Image 2) and Mr. Pressley stated that when the cow was initially placed, it was covered in a layer of compost, but the carcass bloated due to the heat, causing it to become exposed to the elements. No additional exposed animal waste was observed on the compost pile. Moderate odors of the decomposing animals were detected in the vicinity of the compost pile. The depth or consistency of the compost could not be determined. Standing water was observed around the composting area that appeared dark brown and had many flies surrounding the puddles (Image 3). The standing water appeared to be stormwater that had leached from the compost pile. A berm made of the composting material was near the largest pool and at the time of the inspection, it appeared that the standing water and compost were confined to the cement pad. Ms. Pressley was asked about stormwater management for this area and discussed grading the area to control run-on/run-off.

Image 2: Carcass exposed in compost pile
Taken by Molly Goodman on 7/31/2023 at 13:05

that the excess material would be added to the compost pile. Ms. Pressley was requested to add adequate cover to the compost area and that putrescible waste should be removed if odors can not be controlled. At the end of the inspection, MOPAC arrived at the site and emptied the containers of acceptable materials.

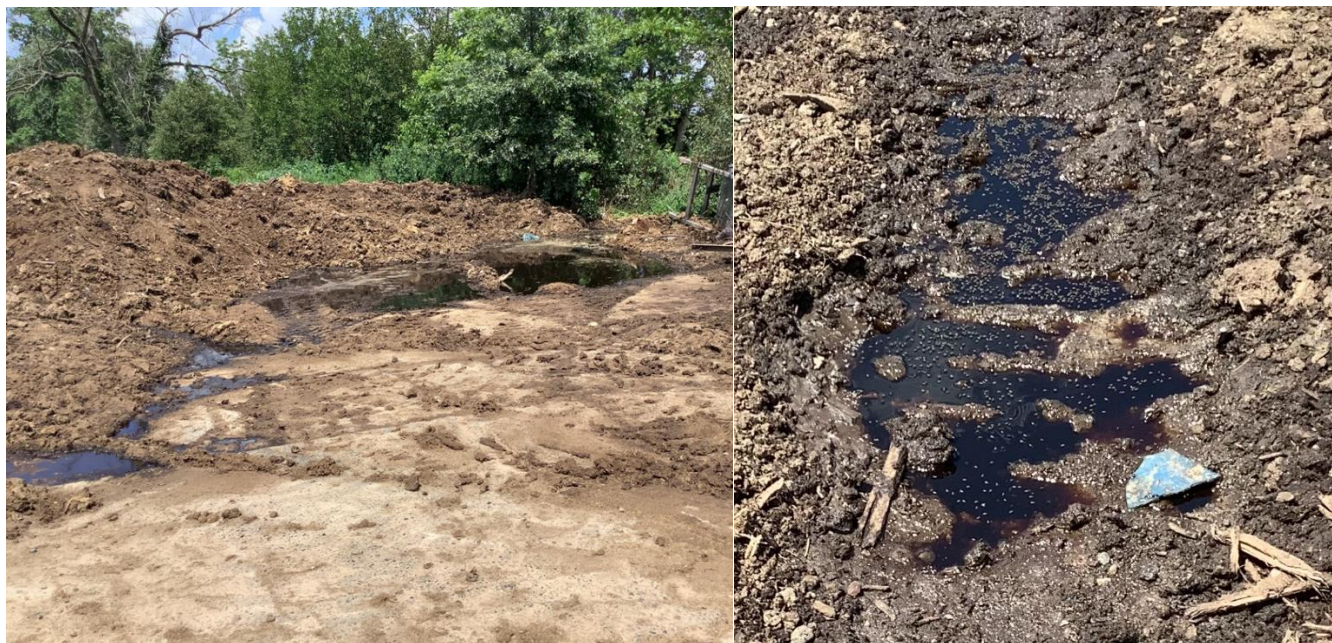
Image 3: Discolored standing water in compost pile
Taken by Molly Goodman on 7/31/2023 at 13:05

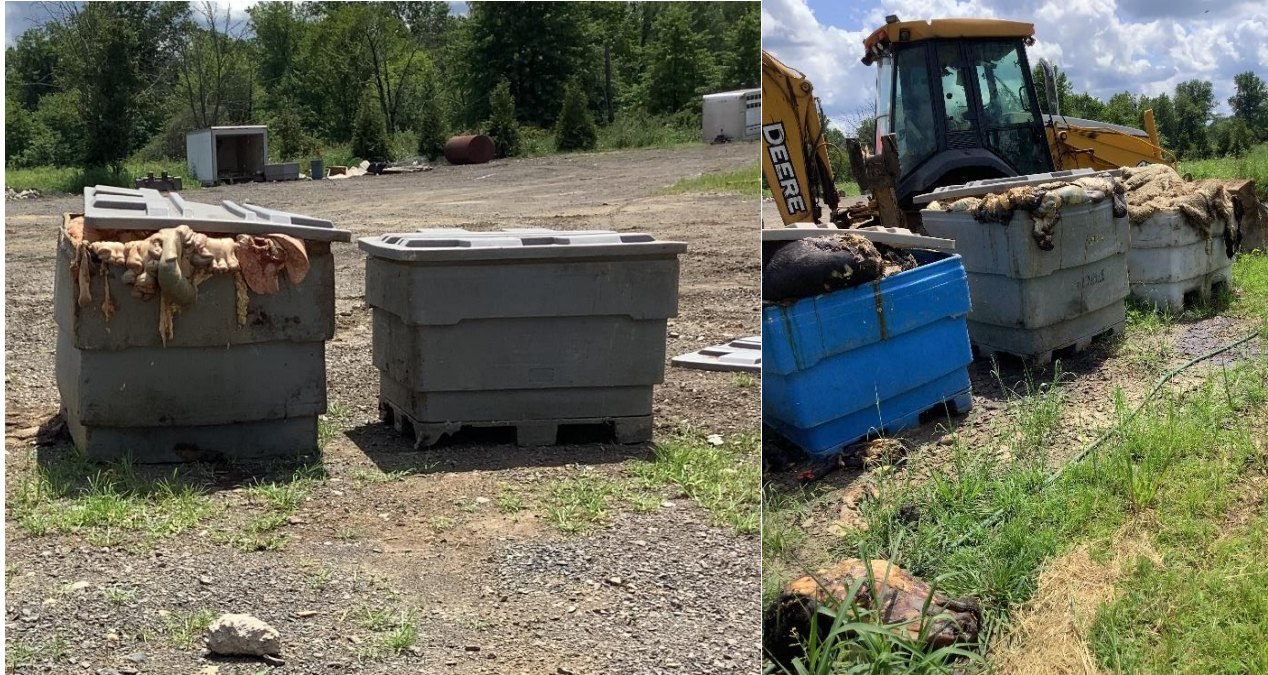
Five (5) containers (Image 4) were observed behind the facility containing the entrails, heads, and hides of slaughtered animals. One (1) container was completely uncovered (Image 5) and was filled beyond capacity. Four (4) had lids that were placed on top of the containers, however, were overfilled so the lids could not properly cover the material. Ms. Pressley stated that a new employee had not punctured the stomachs of the slaughtered cows before placing in the container and the stomachs had expanded in the heat, causing the lids to lift. A backhoe was observed containing the spines and ribs from slaughtered cows (Image 6). A large number of flies and a very strong odor of decomposing animals was observed in this area. Ms. Pressley stated

Image 4: Containers of entrails, heads and skins of slaughtered animals
Taken by Molly Goodman on 7/31/2023 at 12:50

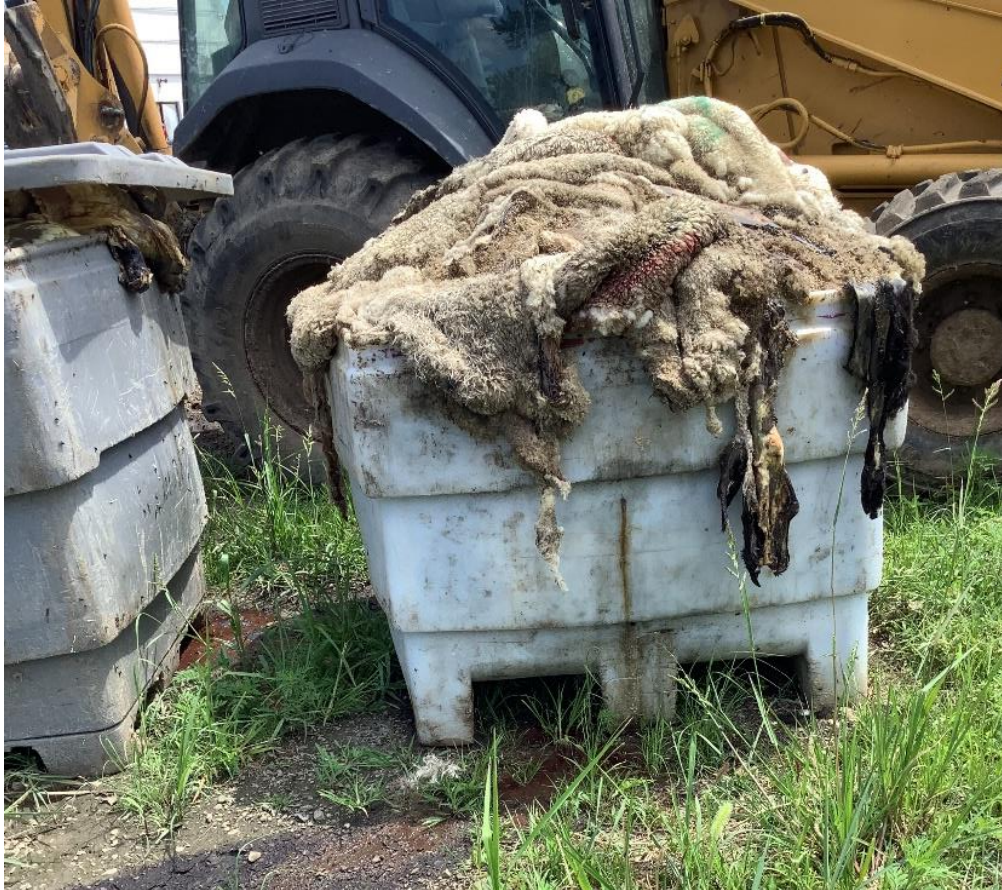
Image 5: Overflowing, uncovered container of animal skins
Taken by Molly Goodman on 7/31/2023 at 12:52

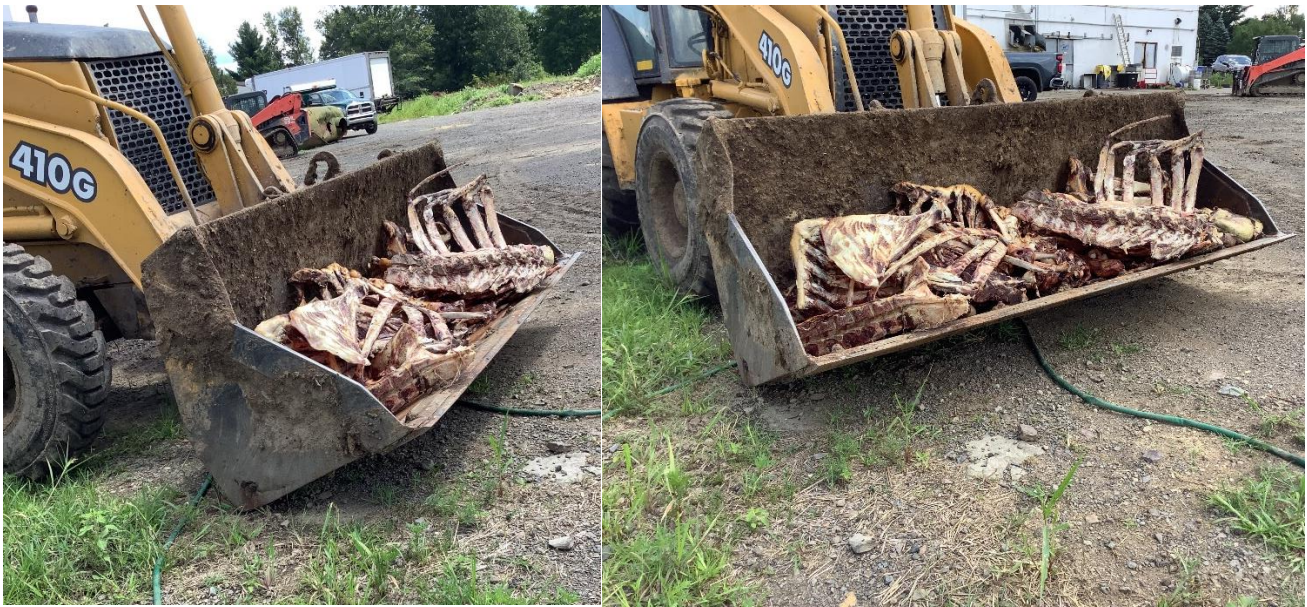
Image 6: Cow backbones stored in bucket of backhoe
Taken by Molly Goodman on 7/31/2023 at 12:59
