Department of Environmental Protection		GENERAL INSPECTION REPORT		Bureau of Land Recycling and Waste Management	
Type of Inspection	WM Identification Number	Entry Time/Date		Inspection ID	
Complaint Inspection	Site ID: 865337	7/6/2023		3581198	
Facility/Incident Name and Location				Municipality	
Kingdom Provisions				Plumstead	
5960 Durham Road Pipersville, PA 18947				County Bucks	
Name, Address of Responsible Official			Title		
Ephriam Stoltzfus Brent Pressley			Owners/Operators		
5960 Durham Road Pipersville, PA 18947			Telephone	Interviewed	
			215-767-8943	Yes <input checked="" type="checkbox"/> No <input type="checkbox"/>

On July 6, 2023, I, Molly Goodman – Solid Waste Specialist, conducted an inspection of Kingdom Provisions, located at 5960 Durham Road, Pipersville, PA 18947. The inspection was in conjunction with Jennifer Ramos-Buschmann, Air Quality Specialist, and William Laufer, Environmental Trainee, from the Department's Air Quality Program and was initiated in response to complaints regarding foul odors originating at the site.

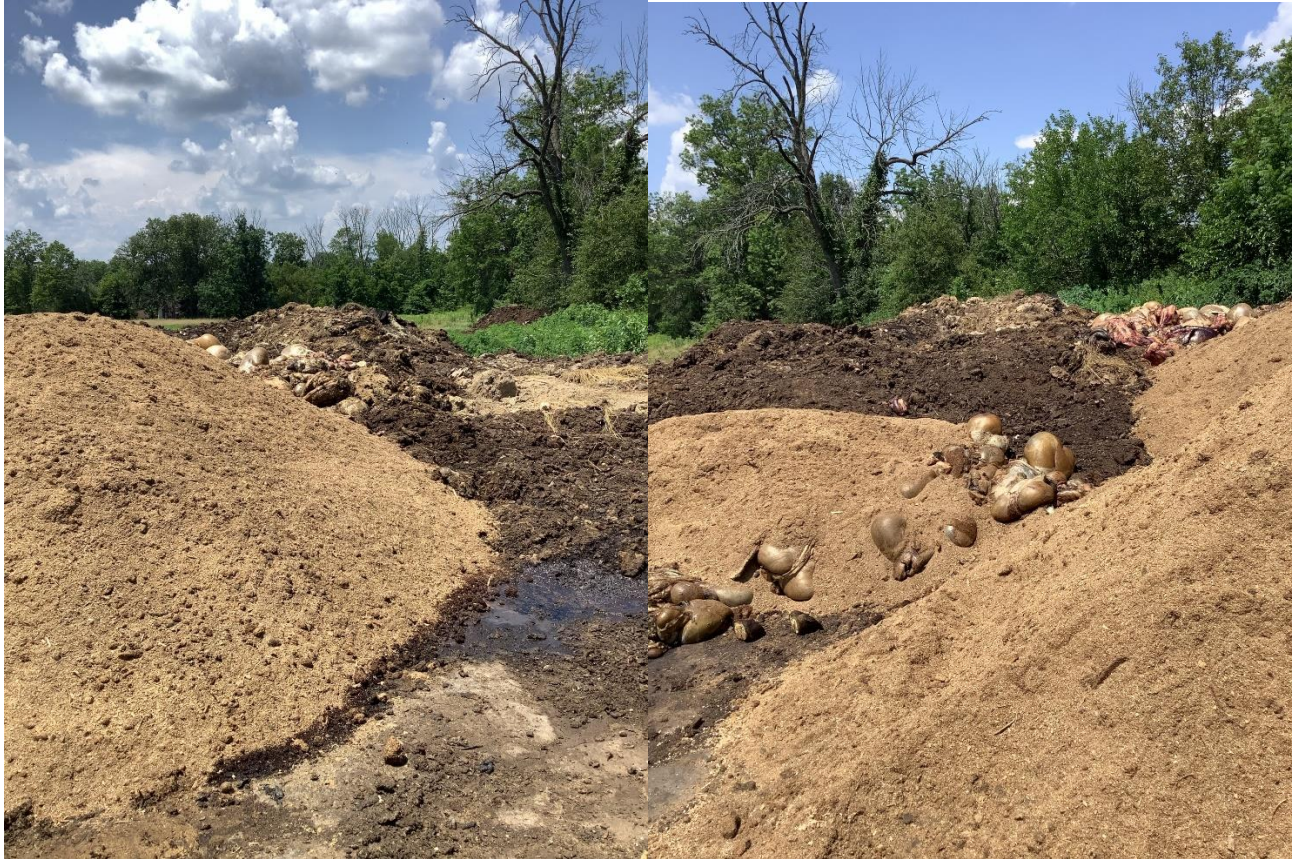
The composting area (Image 1) contained a layer of exposed animal entrails and Mrs. Pressley stated that the compost is turned and covered. The facility was reminded to immediately cover the material after adding to the pile. A container and cardboard box (Image 2) were observed adjacent to the compost pile and contained open plastic bags of what appeared to be old meat. A large quantity of vectors was observed, and the facility was reminded to properly containerize food processing residual wastes. An additional container (Image 3) was observed to have a dark sludge from the decomposition of skins and bones. Mrs. Pressley stated

Image 1: Compost pile with exposed animal entrails
Taken by Molly Goodman on 7/6/2023

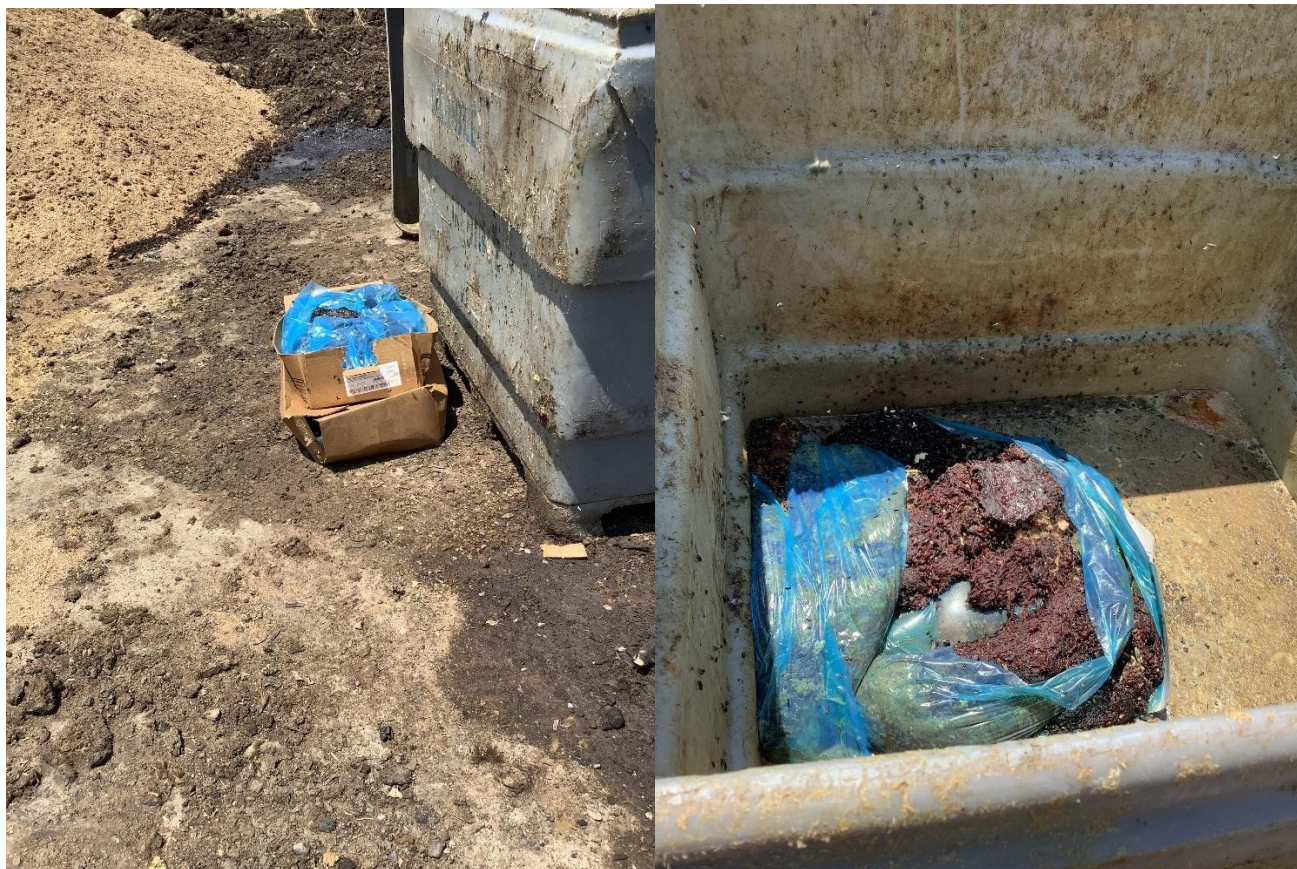
Image 2: Open bags of remains adjacent to compost pile
Taken by Molly Goodman on 7/6/2023

that she would remove the material immediately and request new, clean containers from Darling Rendering. Mrs. Pressley stated that she will send the Department a copy of a receipt or other evidence that the material has been removed from the site.

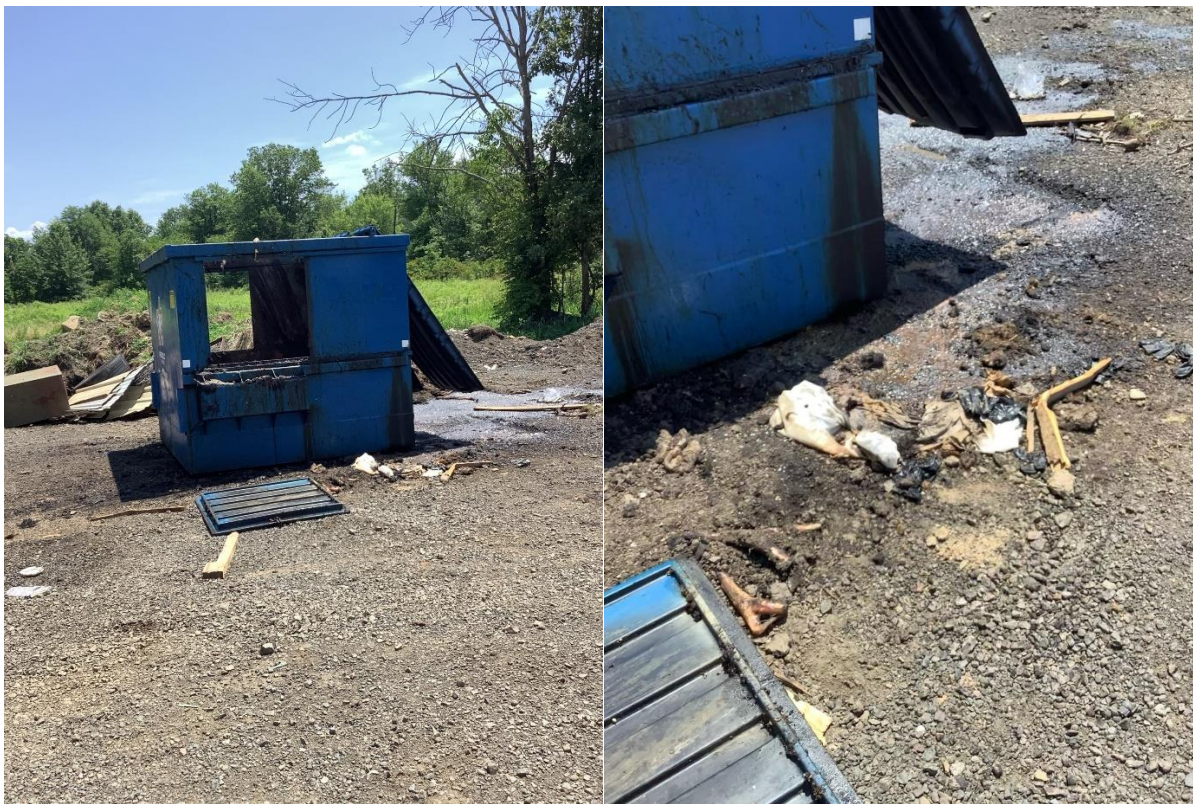
The dumpster at the site (Image 4) was observed to be approximately half-way full of a conglomerate of skin, bones, and non-animal biproducts of the residual waste operation (Image 5). The dumpster appeared to be leaking fluids and the facility was actively covering the affected areas of the ground. The facility was reminded to properly containerize waste materials in a manner that prevents leaks or other releases. Additionally, the facility was requested to submit to the Department a copy of a disposal receipt.

Image 4: Container with fluids leaking onto gravel
Taken by Molly Goodman on 7/6/2023

Kingdom Provisions should respond within 10 days of receipt of this inspection report with documentation in the form of a disposal receipt demonstrating the proper disposal of the putrescible waste in the containers. Furthermore, Kingdom Provisions should provide a plan describing future waste handling from the slaughtering operation as well as BMPs to be implemented to address the composting and application of the waste.

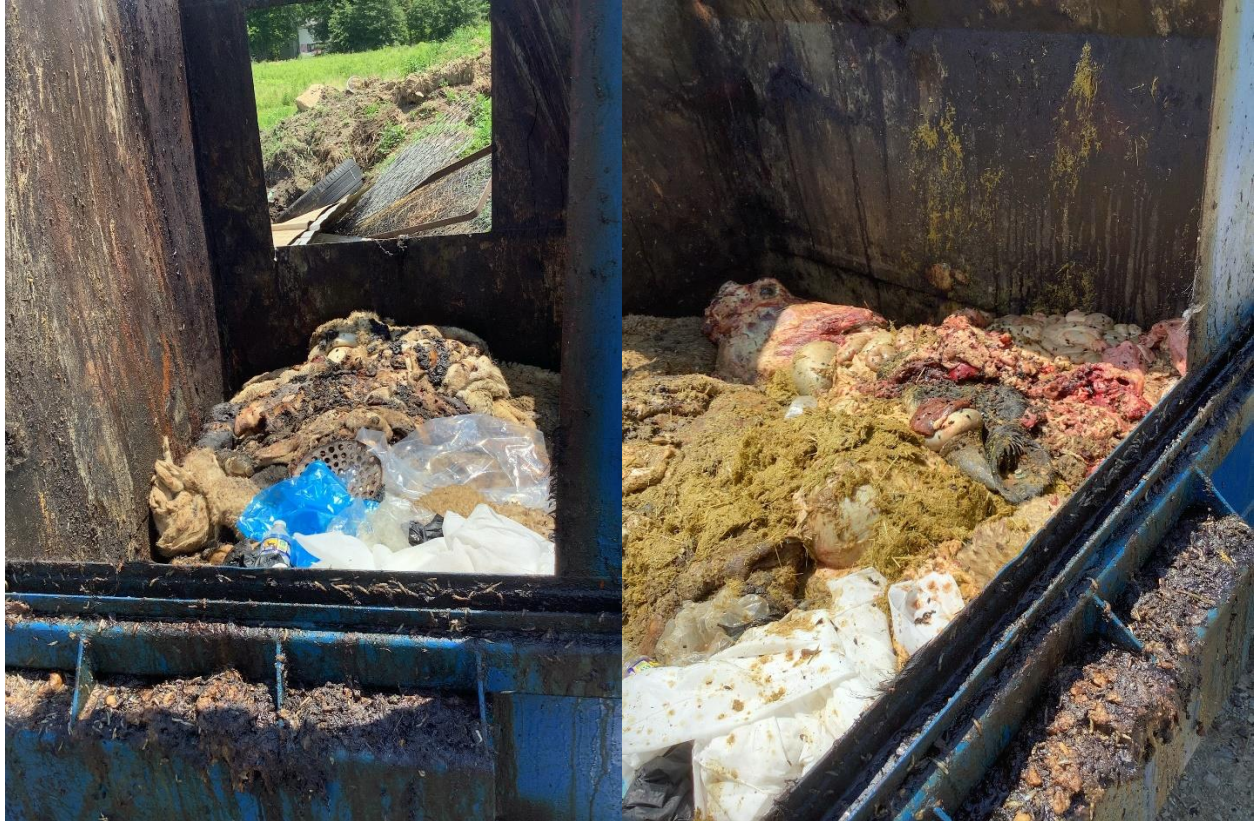
Image 5: Contents of dumpster onsite
Taken by Molly Goodman on 7/6/2023
